**Flood Control Project Maintenance
Levee Inspections**

Maintenance Issue Types Only, Levee Inspection Report By Mile - Spring 2016

Solano County Public Works Mellin Levee

Waterway	Bank	Unit Miles	Inspection Start/End	Inspector
Unit No. 01 Mellin Levee	Right	0.59	03/24/2016 03/24/2016	Richard Willoughby

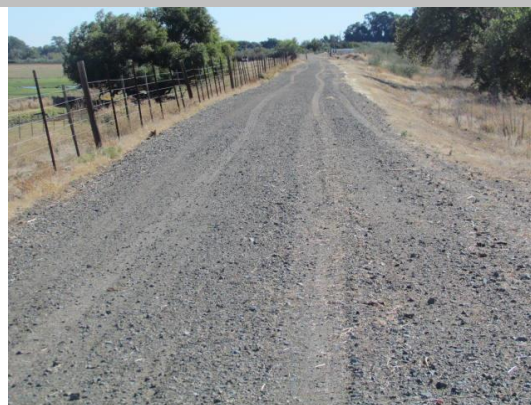
Photo 1 of 3 : SP_2016_NA0012_258_10_20160308_00007.jpg

LM Start	0.15	Rating **	M	Issue No.	10
LM End	0.59	Issue Type +	Ma	Location *	CR
Category	Earthen Levee			GPS Latitude/Longitude	
				Start	End
Item	Crown Surface / Depressions / Rutting			38.175627 °	38.180044 °
				-121.676185 °	-121.681978 °
DWR ID	DWR_NA0012_01_s_2015_10				
Comment Code					
C1 : Add appropriate material and re-grade the levee to bring the crown above the design elevation.					
Inspector Comment					
Add appropriate gravel or road base.

Looking east at levee crown fall 2015.

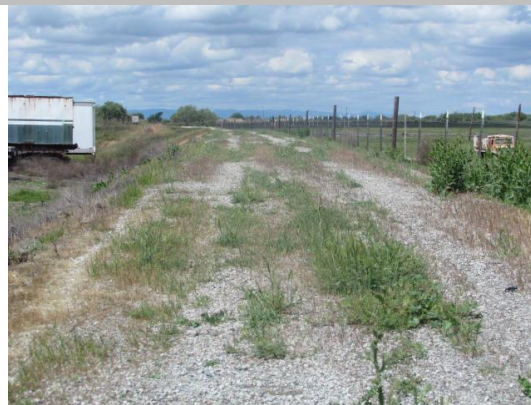
Photo 2 of 3 : SP_2016_NA0012_258_10_20160308_00008.jpg

Looking west at vegetation on levee crown at LM 0.00 to 0.10

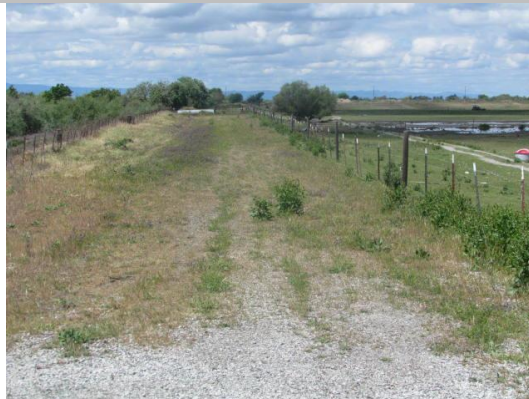
Photo 3 of 3 : SP_2016_NA0012_258_10_20160308_00009.jpg

LM Start	0.15	Rating **	M	Issue No.	10 (cont)	
LM End	0.59	Issue Type +	Ma	Location *	CR	
Category	Earthen Levee			GPS Latitude/Longitude		
				Start		End
Item	Crown Surface / Depressions / Rutting			38.175627 °		38.180044 °
				-121.676185 °		-121.681978 °
DWR ID	DWR_NA0012_01_s _ 2015_10					
Comment Code						
C1 : Add appropriate material and re-grade the levee to bring the crown above the design elevation.						
Inspector Comment						
Add appropriate gravel or road base.

Looking west at vegetation on levee crown at LM 0.28 to 0.59

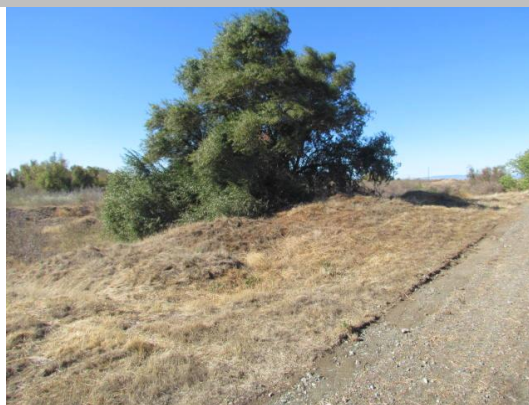
Photo 1 of 2 : SP_2016_NA0012_258_12_20160308_00010.jpg

LM Start	0.58	Rating **	U	Issue No.	12
LM End	0.58	Issue Type +	Ma	Location *	LS
Category	Earthen Levee			GPS Latitude/Longitude	
				Start	End
Item	Trim / Thin Trees			38.179966 °	38.179966 °
				-121.681872 °	-121.681872 °
DWR ID	DWR_NA0012_01_s _ 2015_12				
Comment Code					
T1 : Trim trees to at least five feet above ground level.					
Inspector Comment

Looking at untrimmed tree on landward slope fall 2015.

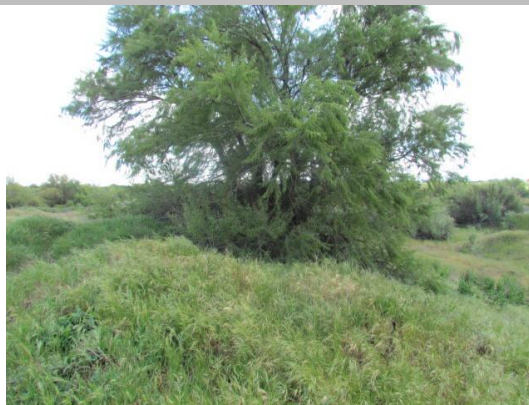
Photo 2 of 2 : SP_2016_NA0012_258_12_20160308_00011.jpg

Looking east at untrimmed tree on landward slope spring 2015
